Water Management Plan

CRYSTAL MOUNTAIN SPIRITUAL EDUCATION CENTRE

February 2022

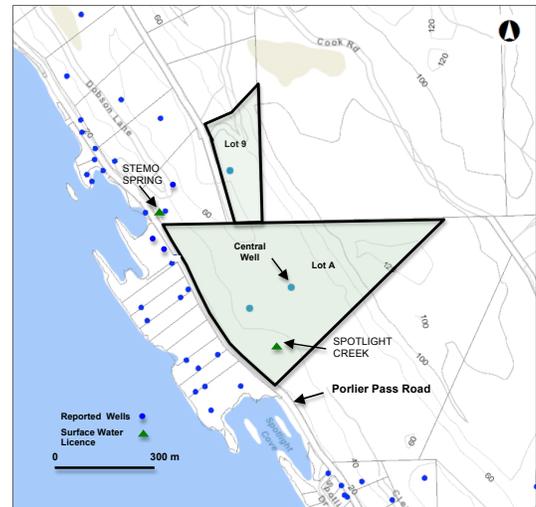
Figure 1 Subject area

Crystal Mountain Spiritual Education Centre (CMSEC) is located adjacent to and east of Porlier Pass Road at the north end of the island near Spotlight Cove (Figure 1). The Crystal Mountain lands include Lot A, District Lots 88 and 89, Plan VIP68079 and Lot 9, District Lot 90, Plan 31200, Galiano Island, Cowichan District. Lot A is zoned Forest 1 (F1) and Lot 9 is zoned Rural 2 (R2) in the Galiano Land Use Bylaw (Islands Trust Staff Report, 2015).

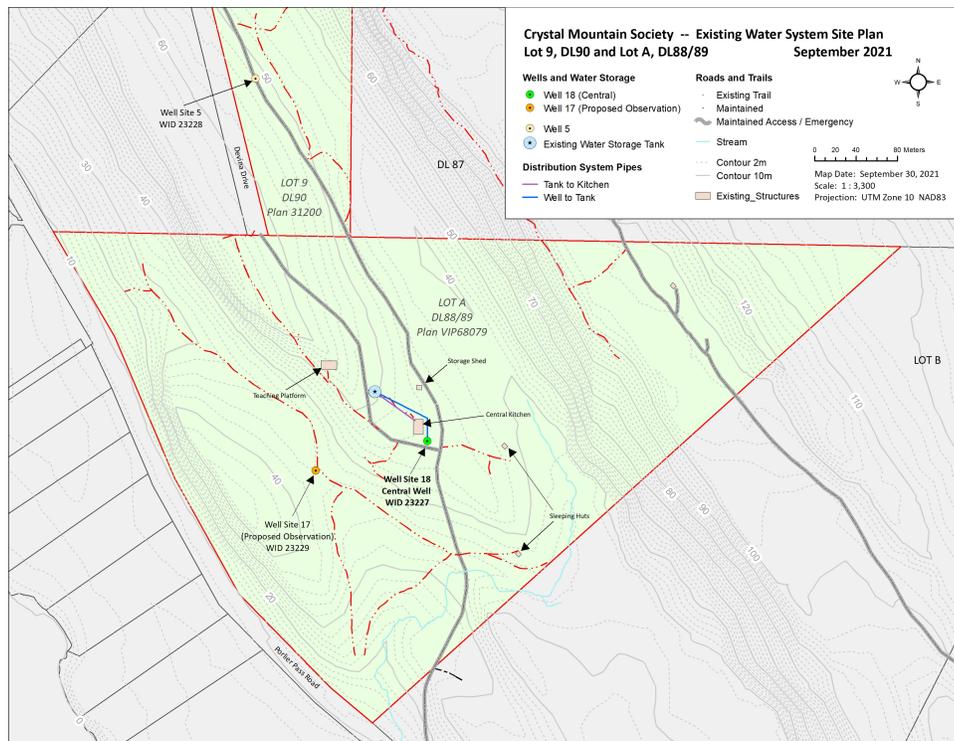
Figure 2 Existing Land-use (larger version found in Appendix A)

The changes from the existing land use (Figure 2) to the proposed rezoning (Figure 3) are provided for reference. The proposed plan includes two defined areas – Area '1' and Area '2' and the amenity transfer demarcation to Islands Trust Conservancy (ITC). See Appendix A and B for larger versions of Figure 2 and Figure 3

Lot A, District Lots 88 and 89, Plan VIP68079 will be comprised of two retreat areas:

- *Primary Retreat Area '1'* (Figure 3)
 - Central Kitchen (existing)
 - 14 meditation/sleeping huts (no plumbing)
 - Rainwater collection system
 - Water treatment system
 - Central Washroom
 - Caretaker Building
 - 1 Meditation Hall (no plumbing)
 - Central Well (WID# 23227) – 125 ft depth; currently in use
 - Observation Well (WID# 23229) – 183 ft depth; not in use
- *Upper Ridge Retreat Area '2'* (Figure 3)
 - Left undeveloped until a new well is drilled and registered
 - Future Upper Bathroom and Kitchen
 - Future 3 sleeping huts (no plumbing)
 - No existing well – planned to have new well developed

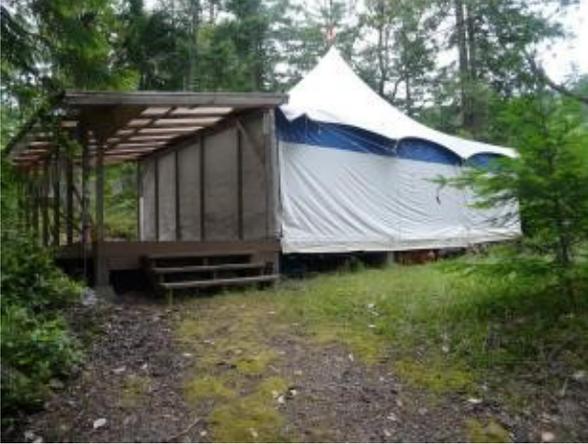
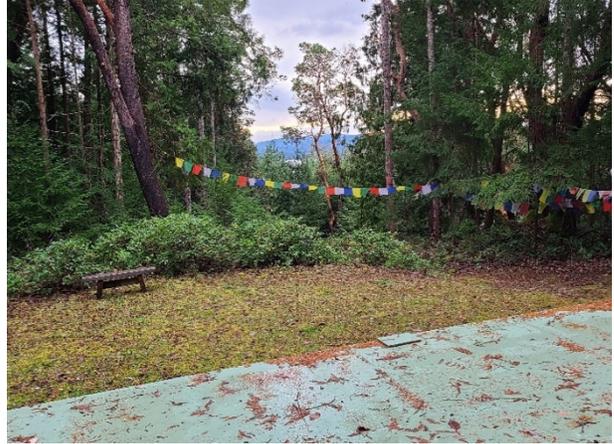
Photo 1 Current meditation platform (to be replaced by ≤ 125 m² structure)

Photo 2 The view out from the meditation platform across the road

Photos 1 and 2 show the current meditation platform and related clearing. Photo 1 (left) is looking at the platform from the road, and Photo 2 (right) is looking out over the road from the platform. This structure is to be replaced with a 125m² (max) meditation hall.

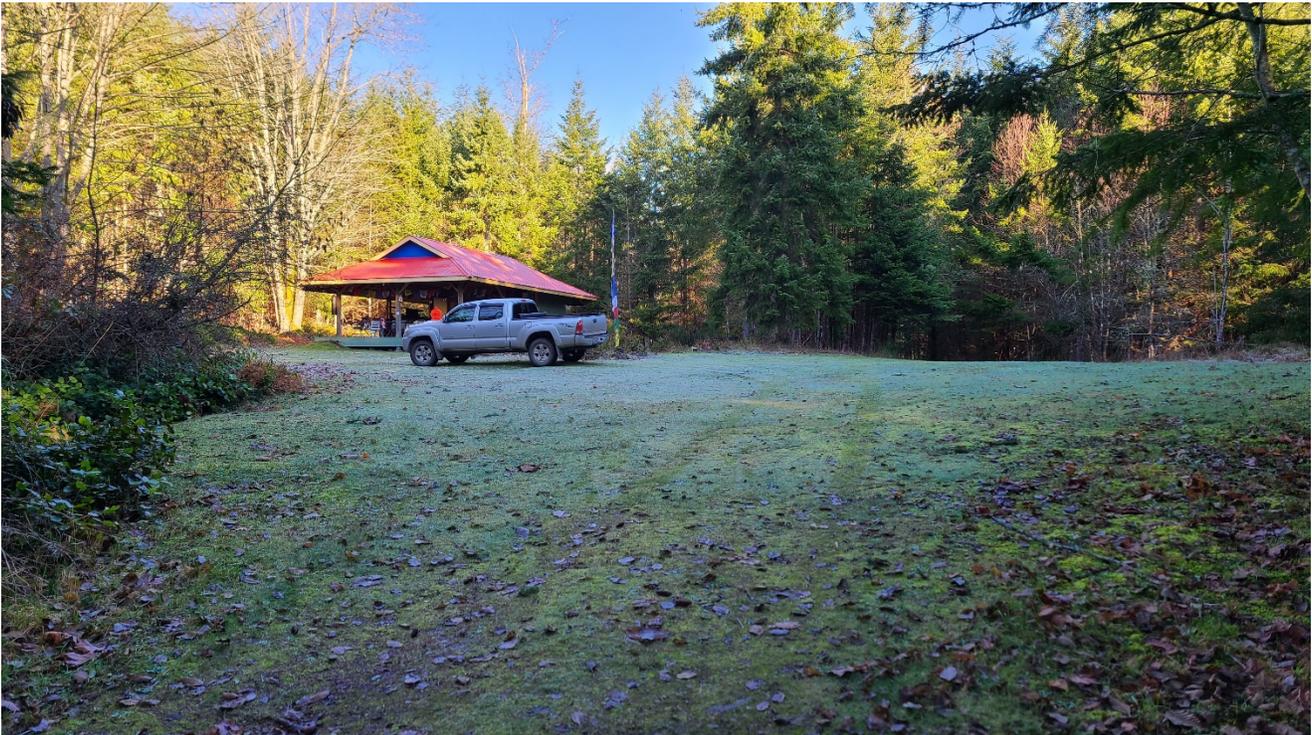
Photo 3 Open air kitchen and landscape

Photo 3 shows the current open kitchen and surrounding cleared area. Access roads branch both to the left and to the right of the photo. Roads are permeable and landscaping is permeable.

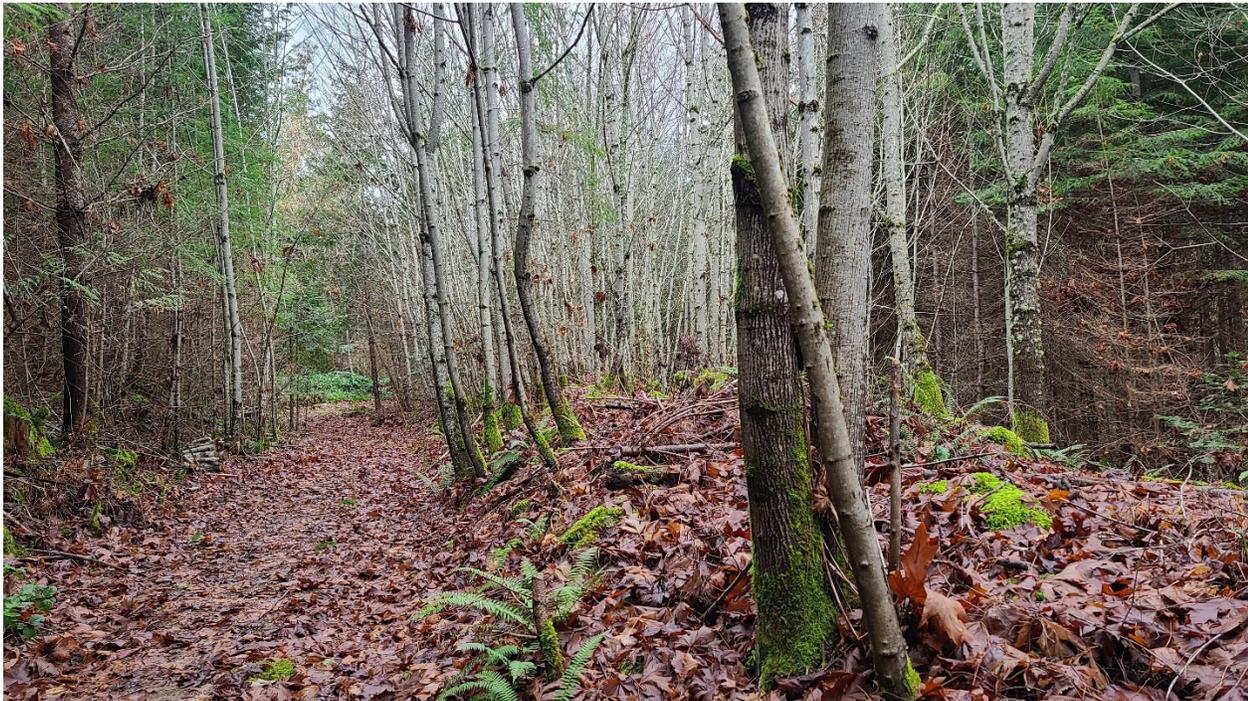
Photo 4 Forested area leading to the kitchen - uphill from kitchen

Photo 4 shows the main access road running down from the end of Devina Road to the Kitchen site. A septic field will be constructed amongst the maple trees on the right. A hydro power line will run down the side of the road and water/electrical lines will be buried underneath. The landscape is rough, undulating, absorbent with no signs of scouring from overland flows of stormwater.

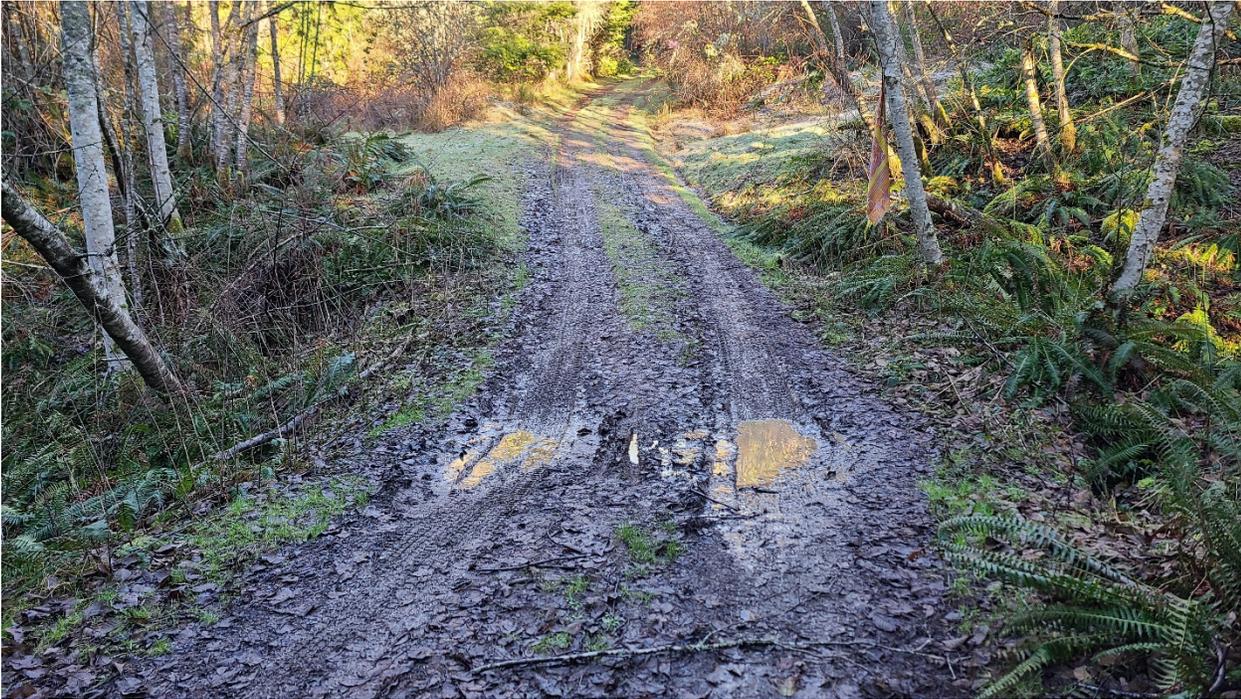
Photo 7 Emergency access road to be transferred to ITC

Photo 7 shows the portion of the emergency access road to be transferred to the Islands Trust Conservancy and brought up to standard. The creek flows under the road from right to left below the depression. A stepped bioswale will be constructed on the right side.

Crystal Mountain access routes utilize existing logging roads through well-drained areas where no significant surface flow has been observed, including during high intensity storm events such as those occurring in November 2021. The one exception is the portion of proposed emergency access road where it crosses the creek (see Figure 4). This portion is being transferred to the Islands Trust Conservancy for nature protection purposes. Prior to transfer, Crystal Mountain has agreed to complete minor road upgrades to bring it up to standard for emergency vehicles. This will include the creation of bioswales alongside the road, to capture surface water, slow its velocity to allow for absorption into soil, and in the case of high intensity storm events, discharge excess surface flow into the creek across rubble to prevent scouring.

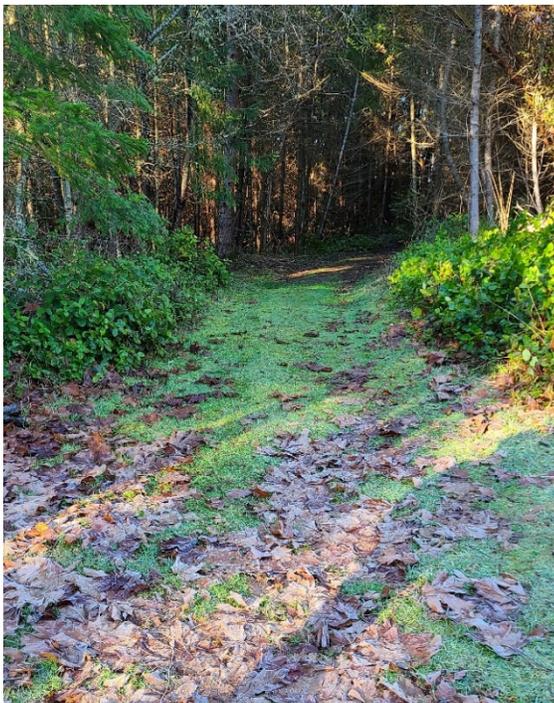
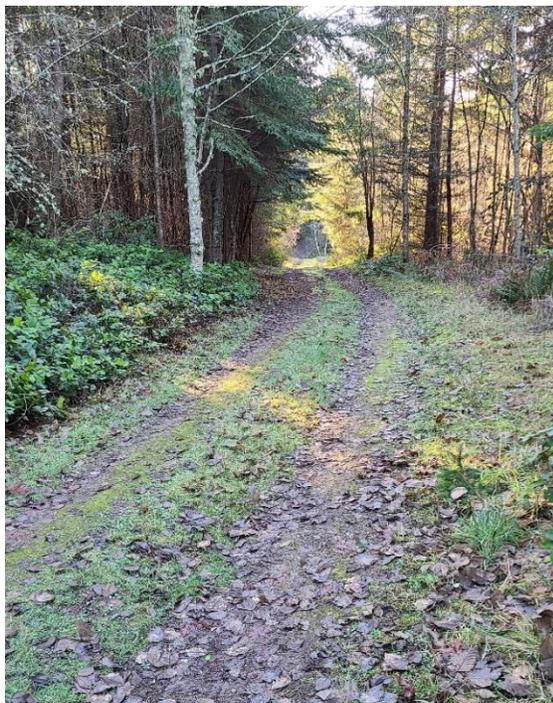
Photo 8 Access road from kitchen toward Devina Dr. (traveling north)

Photo 9 Access road from kitchen toward creek (traveling south)

Photo 8 (left) shows the primary access road leaving the kitchen site up towards Devina Dr. Photo 9 (right) shows the access road leaving the kitchen site down towards the creek.
